Icon smooth surface

Case Reports

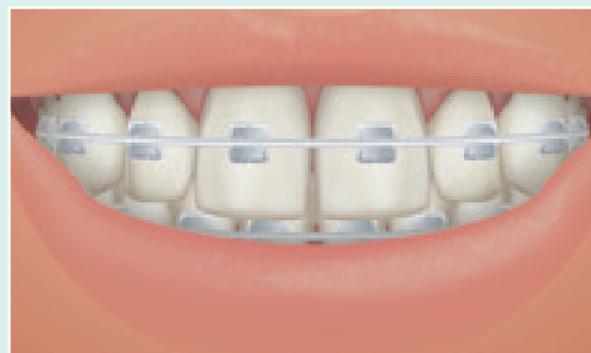
Patient history or etiology. Orthodontic treatment with fixed brackets.

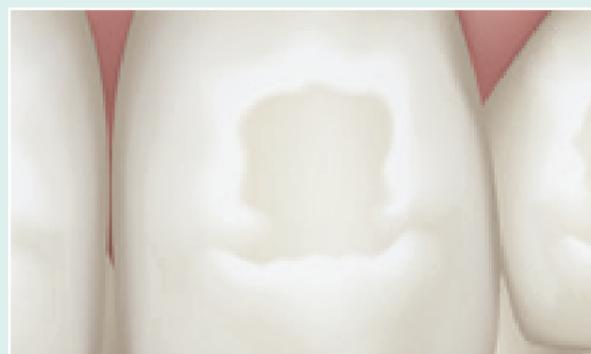
Border. Well-demarcated.

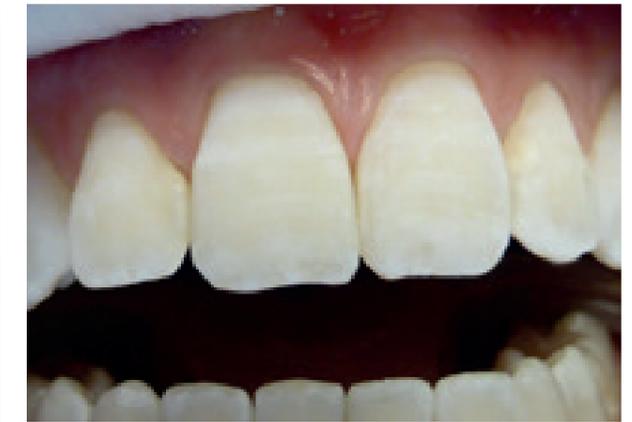
Fig. 7: Result after etching with Icon-Etch five times.

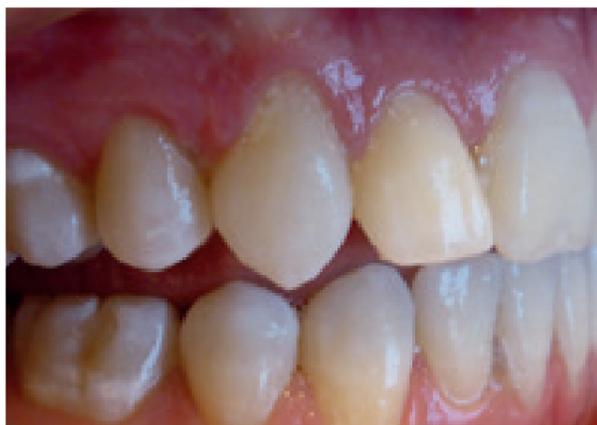
After infiltration, a significant masking was apparent, deemed highly satisfactory by the patient, of both the fluorotic enamel areas and the enamel areas decalcified by the orthodontic treatment.

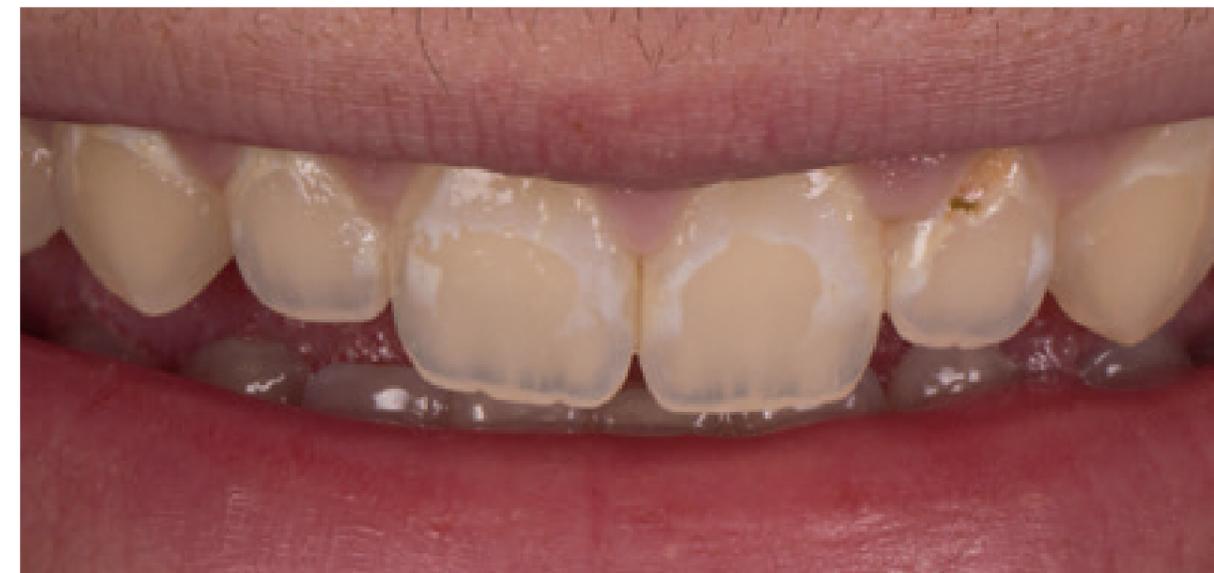
Fig.1: Initial situation before treatment with Icon.

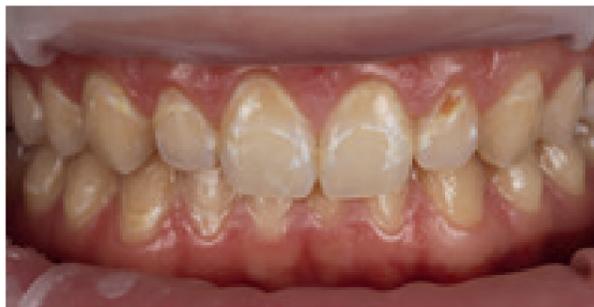
In order to fulfill the patient’s desire of an esthetic improvement we suggested an Icon treatment to mask the lesions.

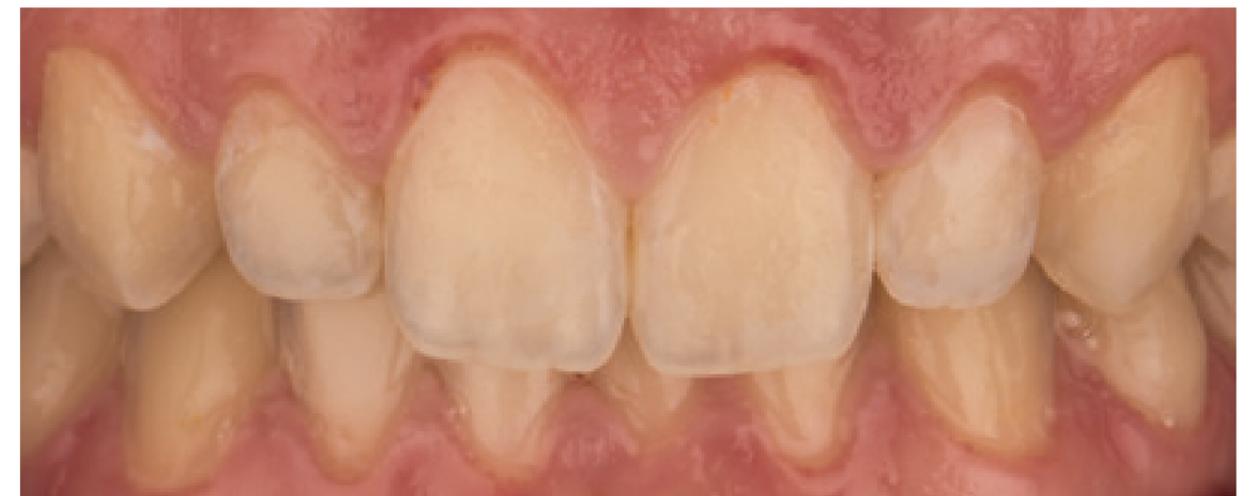
Fig. 10: Final result after Icon treatment. The white spot lesions are masked and a highly satisfying result with large improvement of the esthetic appearance could be achieved.

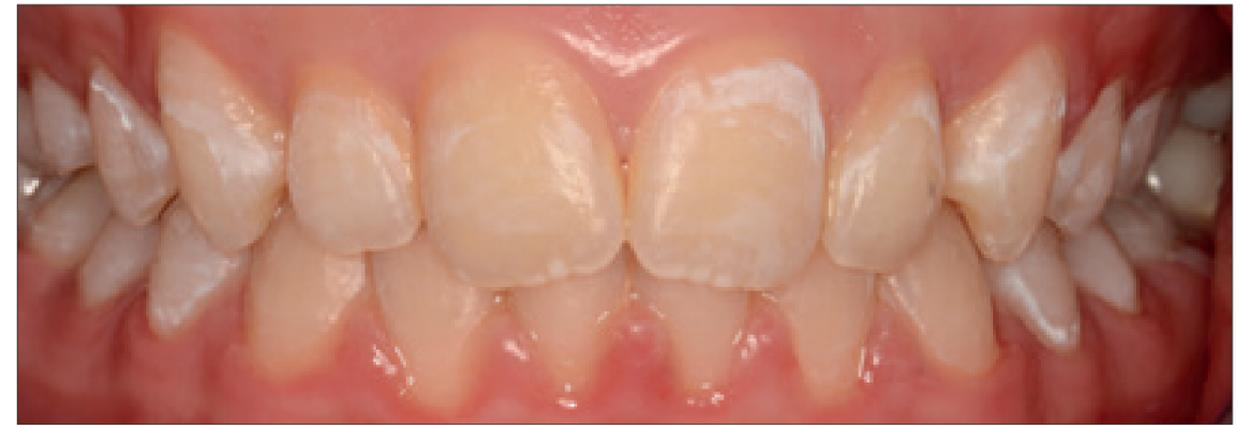
Fig. 3: Directly after removal of the brackets.

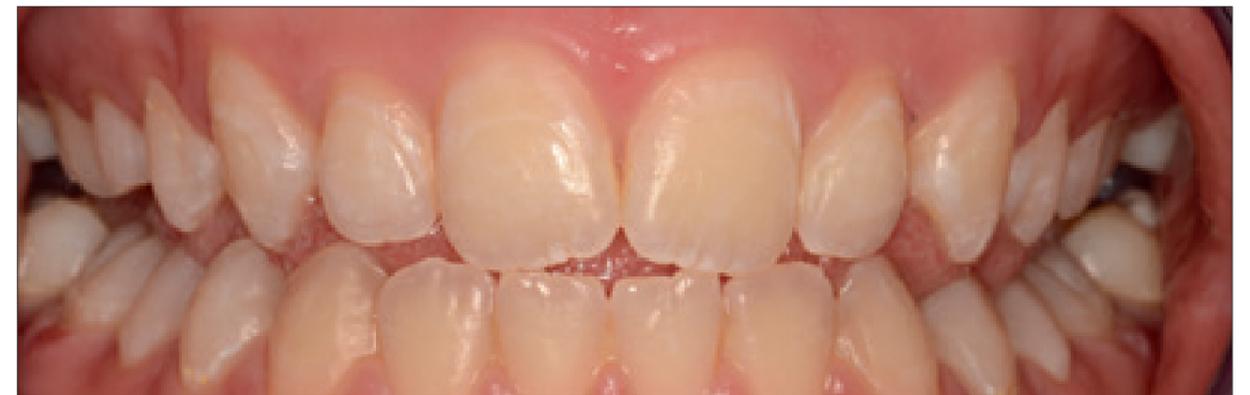
Fig. 4: One week after removal of the brackets and after infiltration of the control teeth.

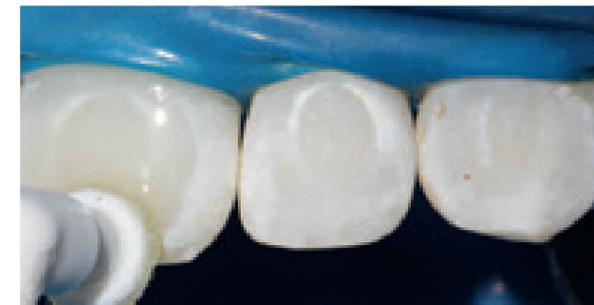
Fig. 3: Prophylaxis with non-fluoridated pumice is completed; teeth are rinsed, then dried. Icon-Etch (hydrochloric acid) is applied, extrude the Icon-Etch by twisting the syringe. Etch should extend approximately 2 mm around the edges of the lesion and be placed

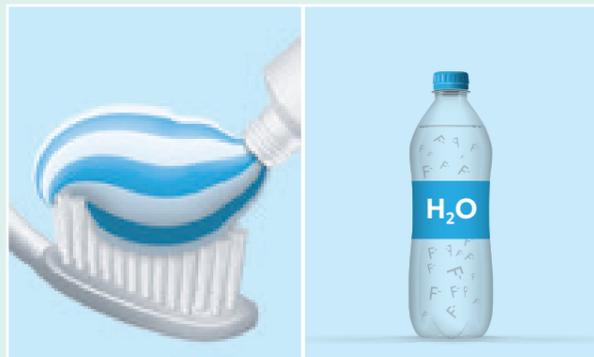
Patient history or etiology. Ingestion of excessive fluoride during enamel formation.

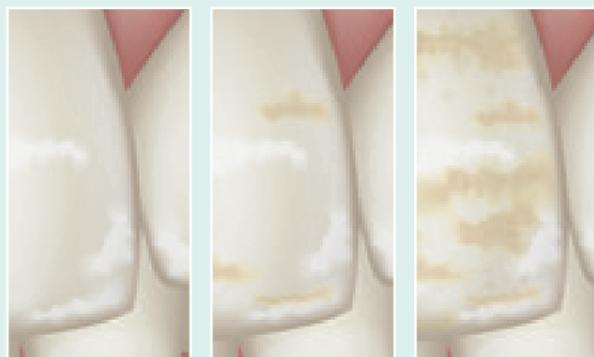
Color. From tiny white specks or streaks to dark brown stains and rough, pitted enamel, depending on the severity.

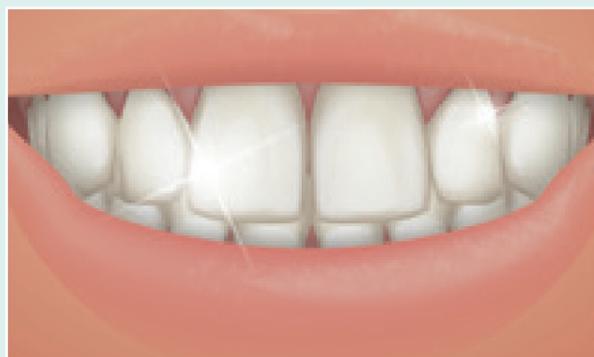
Other unaffected teeth. Smooth and glossy. They should also be a pale creamy white.

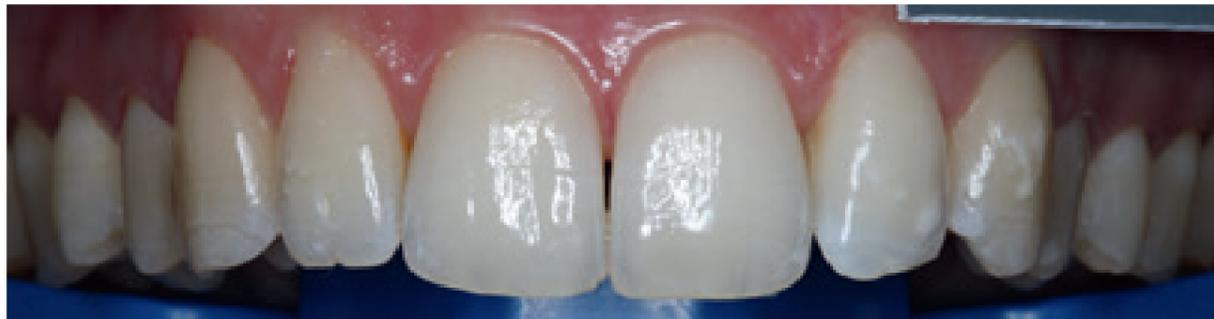
Fig. 1: Base status. Case 1.

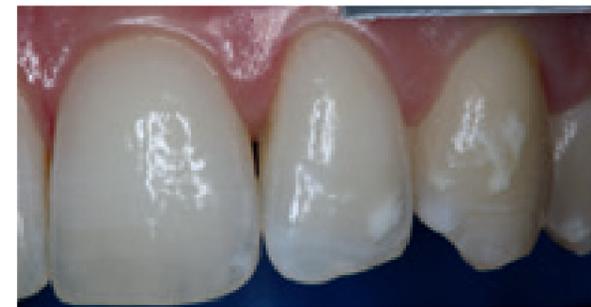
Based on positive results mostly published in case reports we hypothesised that in-office bleaching prior to resin infiltration improves the quantifiable and self-assessed aesthetic effect in mild to moderate dental fluorosis. 26 patients were included in a RCT. The test group received an in-office light enhanced power bleaching with 25 % hydrogen peroxide (Zoom, Philips, NL); the control group was pre-treated accordingly using an ACP gel (Relief Oral Care Gel, Philips, NL) instead of the active substance. After two weeks both groups were infiltrated (Icon, DMG, Germany). Digital images were taken at every appointment and after 1, 3 and 6 months respectively. Based on calibrated images Delta E-values between health enamel surface and fluorosis Spots were calculated. Additionally patients' were asked as to how they judge their overall appearance on a VAS (1-10).

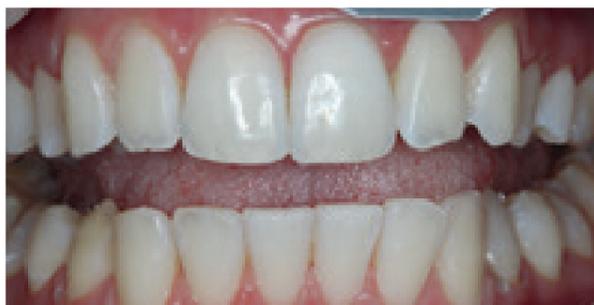
Fig. 8: Case 1 before infiltration. After in-office bleaching we waited for 2 weeks before the infiltration procedure. After rehydration the teeth appear more uniform yet brighter in colour. The treatment protocol intended application of hydrochloric acid for 6 minutes (three rounds, 2 minutes each) and 10 minutes of infiltration and one additional minute after the initial infiltrating procedure. The prolonged etching and infiltration increases the probability to sufficiently remove the intact surface layer and allows the infiltrant to homogeneously fill up deeper porosities. Apart from these modifications the infiltration process was performed as recommended by the manufacturer.

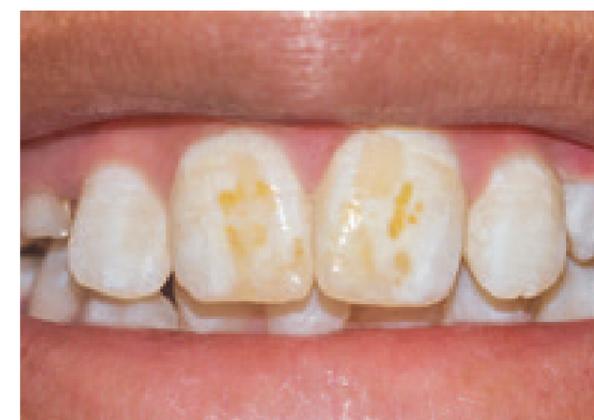
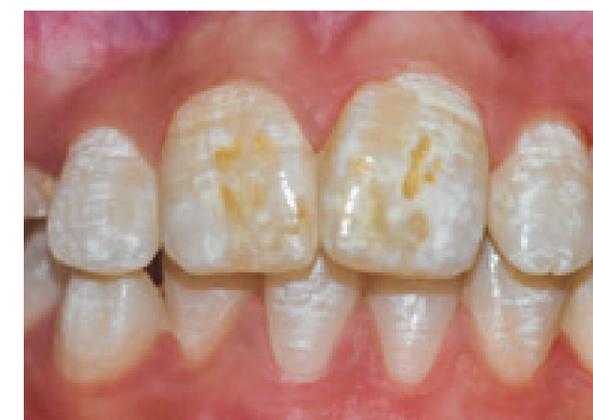
Fig. 1-2: Through a clinical exam, it was diagnosed that all of permanent anterior teeth, which were erupted, had fluorosis. However, the teeth 11 and 21 were more severely affected according to Thylstrup and Fejerskov index [12].

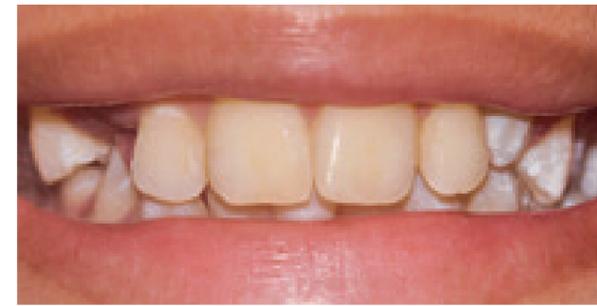
Fig. 11: The final aspects one week after the treatment.

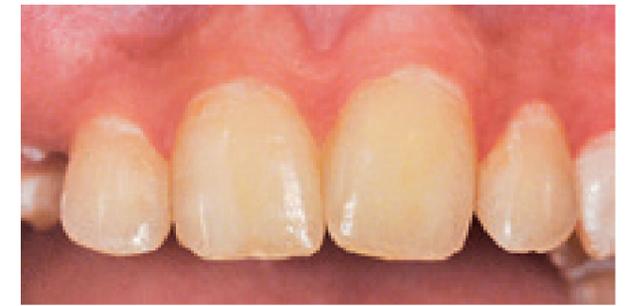
Fig. 12: Follow-up of 4 months. The guardians signed an informed consent form regarding all the procedures.

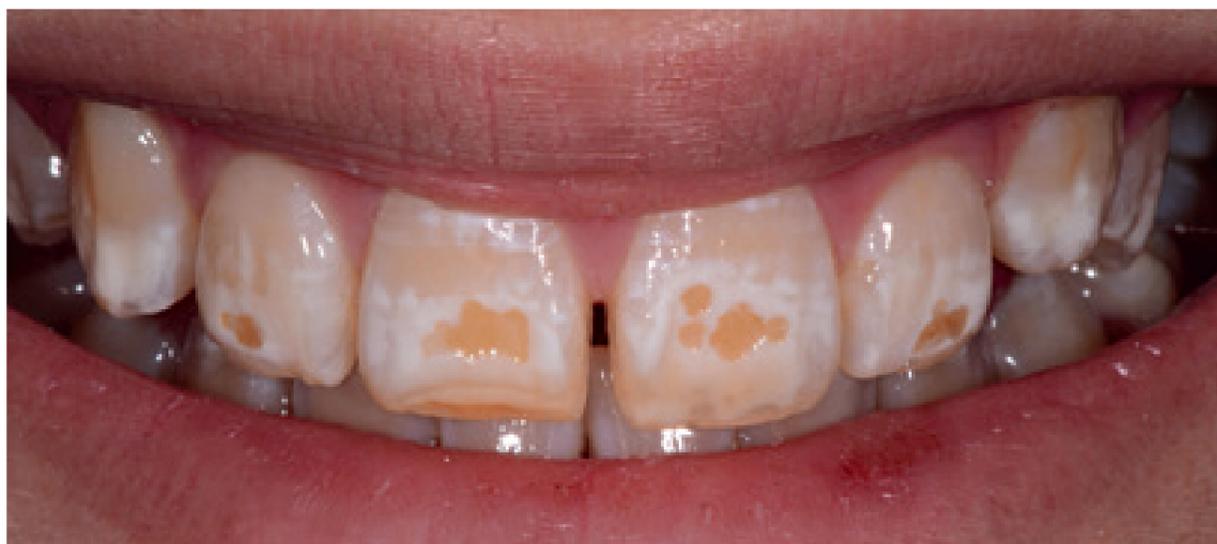
Prof. Dr. Leandro Augusto Hilgert, Marília Bizinoto Silva Duarte

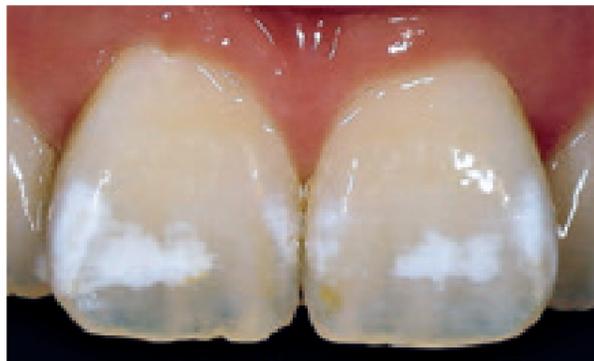
Fig. 1: Frontal view of the white spots 11, 21.

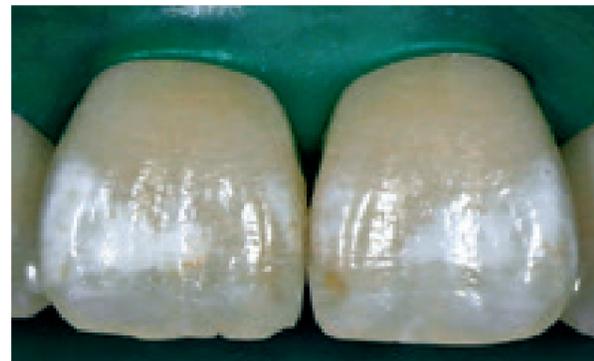
Fig. 2: Firstly, the teeth should be cleaned or (as in our case) a professional dental cleaning should be done. A protection of the mucous membranes using a dental dam is performed.

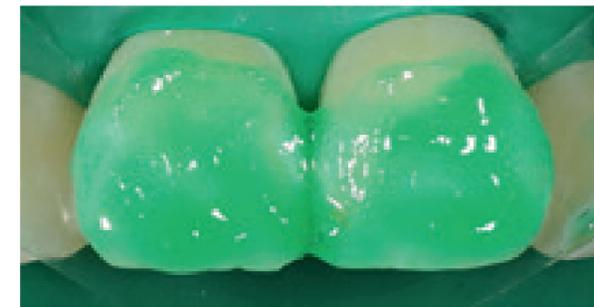
- Icon-Infiltrant can penetrate into porosities in fluorosis white spots and thereby minimizes the difference of refractive index between the health enamel and fluorosis white spots.
- The number of etch times will be decided according to the assessing in Icon-Dry step. When the expected result is not achieved, the white spot need to be etched and dried again before infiltration step.
- Icon infiltration is a promising and micro invasive treatment for the patient impaired by fluorosis white spots.

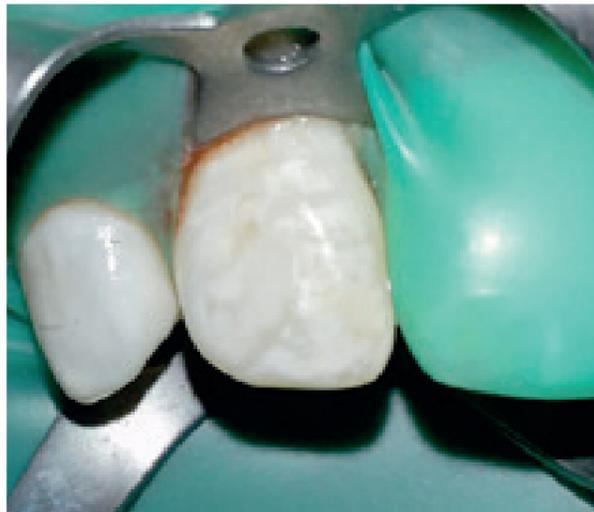
Prof. Dr. Neeraj Gugnani

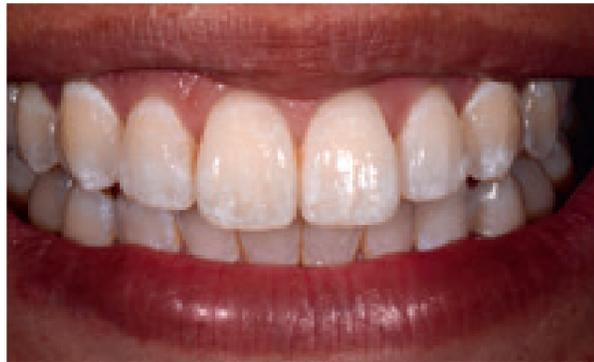
Prof. Dr. Leandro Augusto Hilgert, Marília Bizinoto Silva Duarte

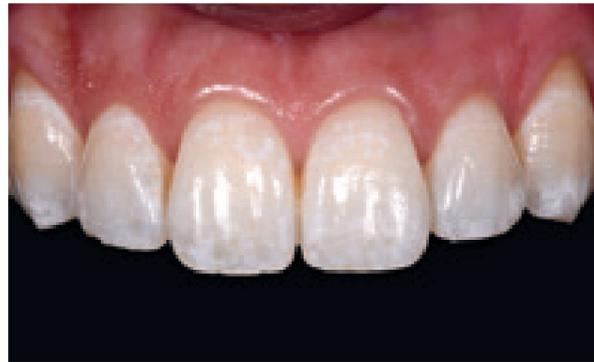
A 26-year old female patient presenting mild to moderate fluorosis looked for esthetic treatment. Her main complaint regarded the whitish diffuse opacities that affected her smile.

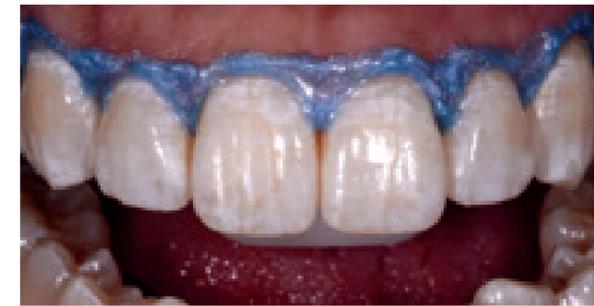
To evaluate the depth of the affected enamel a clinically useful tool is to perform transillumination. Specific equipment or even a simple light curing unit can be positioned on the lingual surface and commanded to emit light. When the transmitted light is not or is only slightly blocked by the opacities, the lesions (enamel porosities) are shallow and the probability of less invasive therapies to be effective is higher. In the present case, this was the situation and the fluorotic lesions were judged shallow, indicating a good prognosis for resin infiltration.

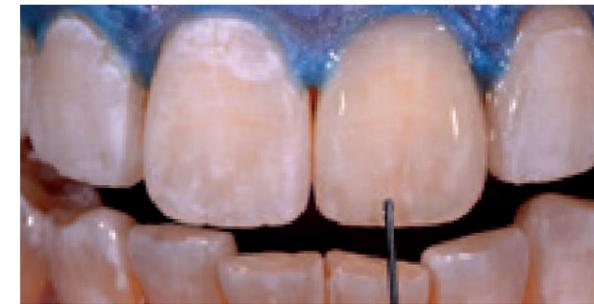
Next step is isolating the teeth that will be infiltrated. Field isolation and protection of the gingival tissue can be obtained using rubber dam or a liquid light-cured resin dam (Top Dam, FGM, Brazil) together with cheeks, lips and tongue retractors. While the liquid dam is usually faster and easier to apply, rubber dam may present a more intense gingival retraction, that may improve results in the cervical area. In this case, the liquid dam was selected and carefully applied to cover as little enamel as possible.

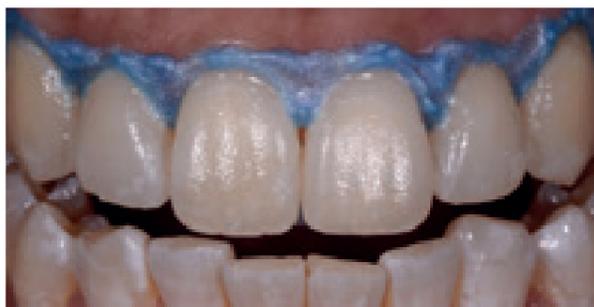
Fig. 9: It is possible to see the immediate aspect after infiltrant polymerization. It is normal to observe a shiny and irregular appearance due to excess of the infiltrant covering the surface. This material is easily removed with polishing instruments as abrasive disks, spirals or rubber cups.

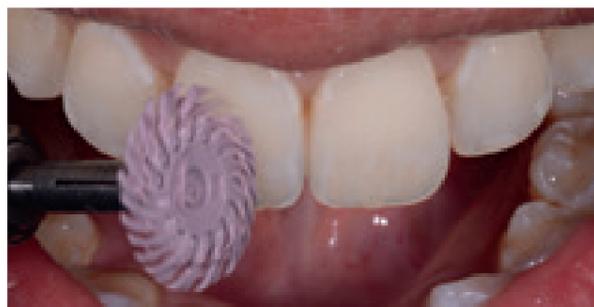
Fig. 10: In the present case polishing was performed using disks and spirals (Sof-lex, 3M, USA).

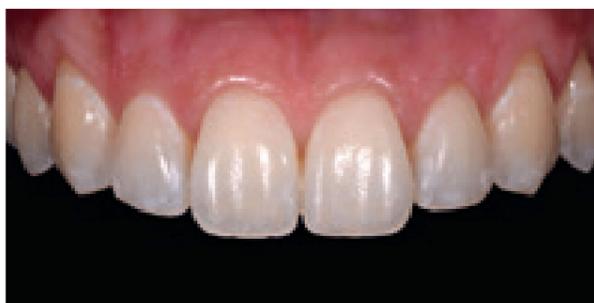
Fig. 11 After polishing, the result of the treatment is shown on Figure 11 and 12. Almost all white opacities disappeared, indicating a satisfactory infiltration of the fluorotic enamel.

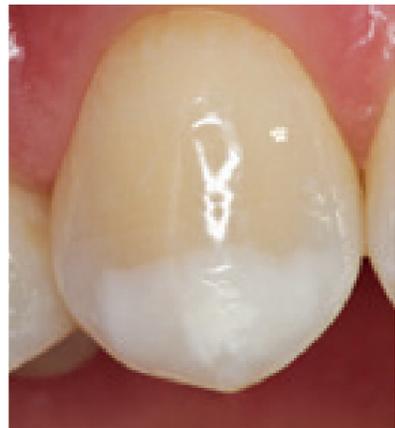
Fig. 1: Initial situation

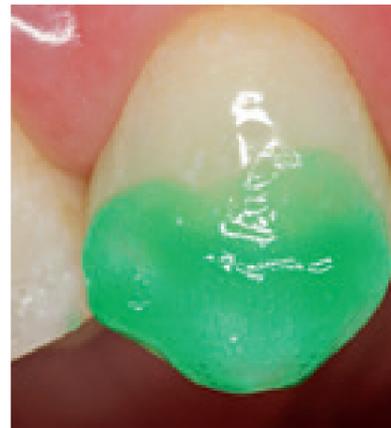
Fig. 2: After cleaning with prophylaxis paste, the affected vestibular area was initially conditioned for 2 minutes with 15% hydrochloric acid gel (Icon-Etch, DMG). At this juncture, the more heavily mineralized surface layer was removed. This shows fewer pores as a result of remineralization processes than the lesion underneath and would thus prevent the infiltrant from penetrating. After 2 minutes, the etching gel was water sprayed off and the lesion carefully dried.

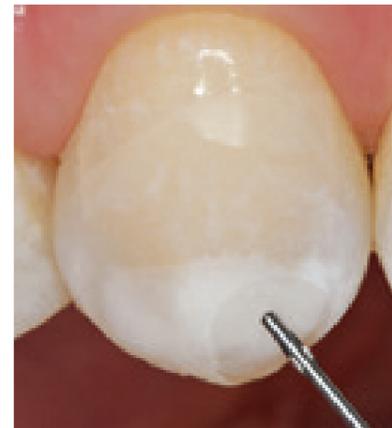
Fig. 3: To achieve further deep drying and at the same time check whether sufficient abrasion of the surface layer was achieved, ethanol (Icon-Dry) was subsequently applied to the lesion. Due to penetration of the ethanol into the lesion's porosities, similar to the later infiltration with resin, the light refraction within the caries was reduced, making the lesion appear less whitish-opaque. When this effect can be observed in the first 2-5 seconds after application of the ethanol, the surface layer is sufficiently abraded to guarantee a quick and complete infiltration.

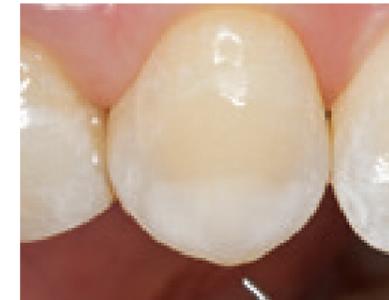
For a better estimate of the esthetic result, the most severely affected tooth (13) was treated first. In the present case, there was no isolation with rubber dam because desiccation and protection of the soft tissue could be guaranteed by an adequate distance to the gingiva.

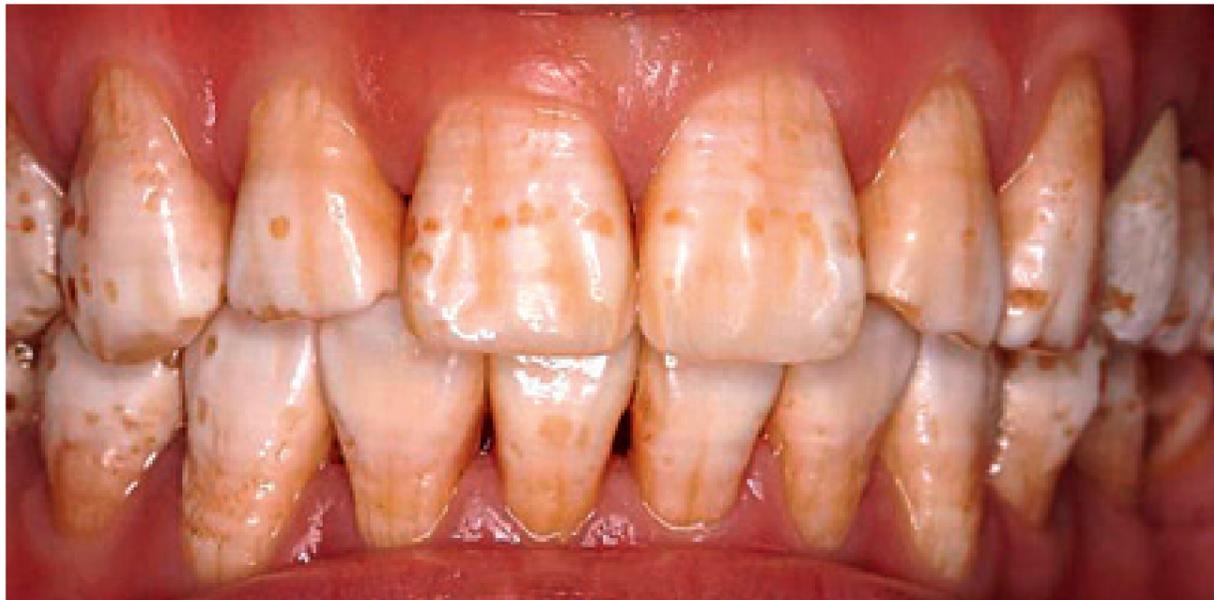
Fig. 1: Before treatment. The full dentition was mottled and defected. We chose at-home bleaching first to improve the color of the teeth.

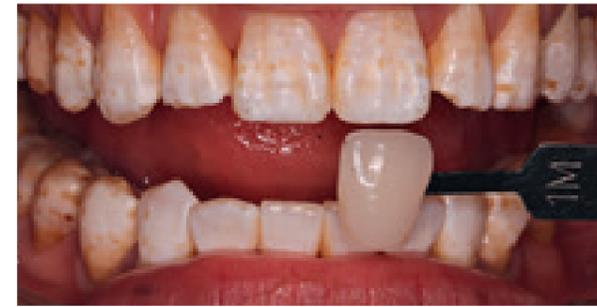
Fig. 2: After the comprehensive clinical examination the colorimetric analysis was done and the color of the teeth was recorded. We made individual bleaching tray for the patient and gave the instructions of at-home bleaching and oral health instruction. After using eight units of Opalescence PF 10 % for four weeks, the color of teeth improved dramatically. We began the Icon resin infiltration treatment.

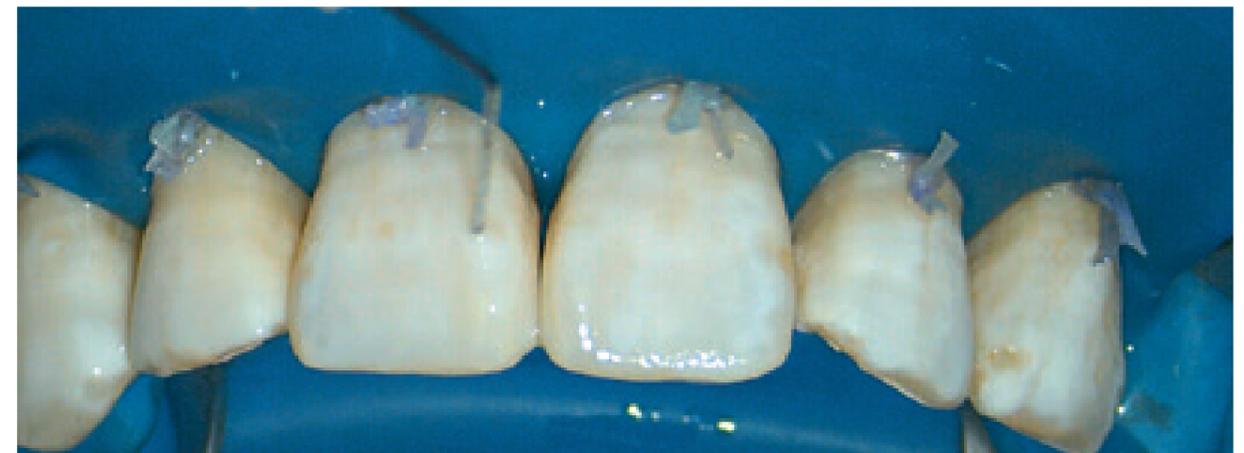
Fig. 5: Screw the application tip onto the Icon-Dry syringe, apply an ample amount of material onto the lesion, and allow to set for 30 s. In this step a preview of the final result is shown. When wetted with Icon-Dry, the whitish-opaque coloration on the etched enamel should diminish. The result of the visual check after the first etching showed that the second etching is necessary.

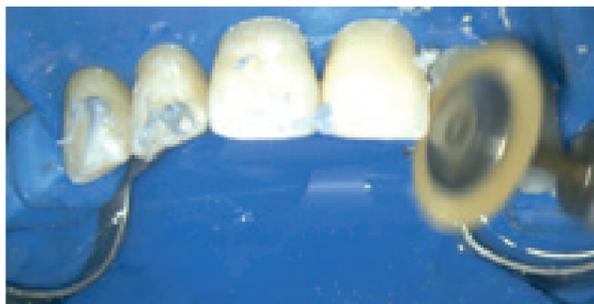
Fig. 10: Polish the teeth surface with wool polishing wheel and ENA SHINY A,B,C paste.

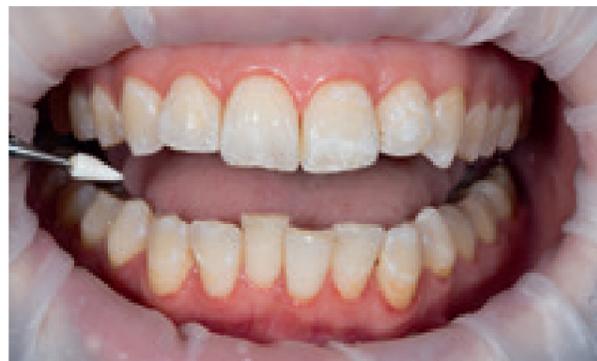
Fig. 1: Start by applying an optragate to get the patients lips out of the way. Then take a white polishing stone and gently polish the enamel surface for a few seconds to get rid of the superficial biofilm on the enamel surface.

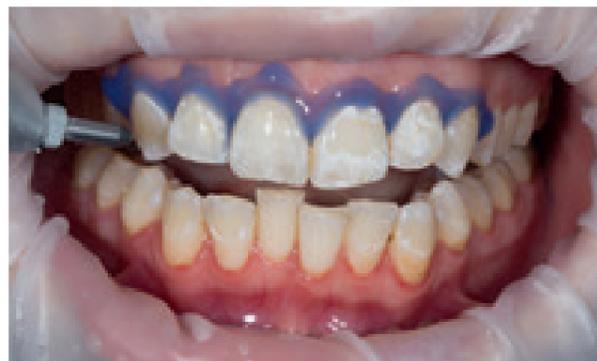
Fig. 3: Blast the white spots with white aluminiumoxide. This will enable better access to the body of the lesion. Blasting of the white lesions should only be done for 2-3 seconds and only once, with the blasting tip positioned approximately 1 cm from the enamel. After completion of this stage the white lesion should give away a matte appearance.

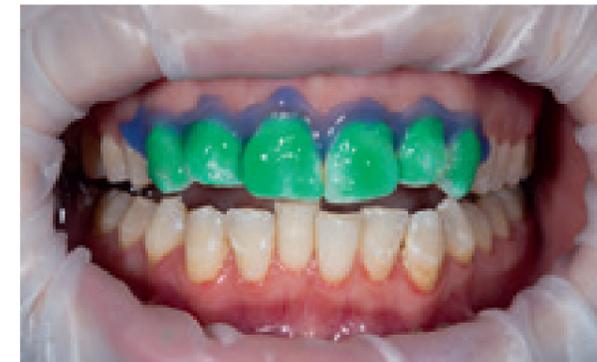
Fig. 4: Apply Icon-Etch over the white lesions and rub it gently for a few seconds with a dry tip until the etch loses its glide and gives away a foamy appearance. Let the Icon-Etch rest on the surface for 2 minutes and then rinse it off with water for at least 30 seconds.

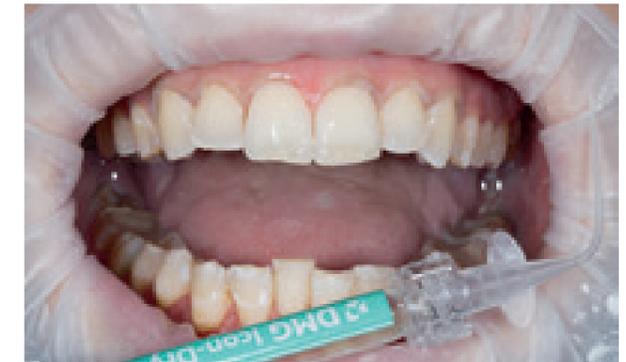
Fig. 5: After careful rinse of the tooth surface, dry with oil-free and water-free air. Then wet the white lesion with Icon-Dry. What you want to see is either a complete temporary masking/disappearance of the white lesion when wetted or a fluctuation in the white color of the lesion when wetted with Icon-Dry. This indicates that the lesion is now accessible for the Icon-Infiltrant.

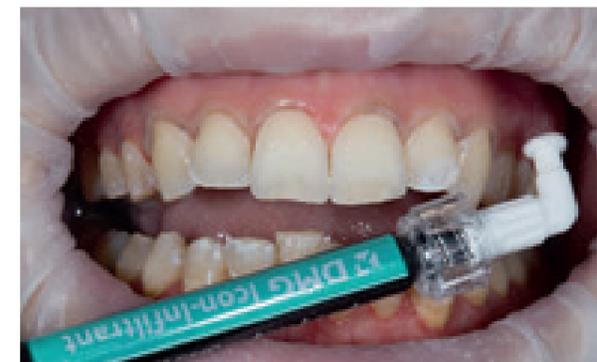
Fig. 6: When the white lesion has responded well to Icon-Dry it is time to use the Icon-Infiltrant. Take your chair attached lamp away from the patient's teeth and apply Icon-Infiltrant on a dry enamel surface. Use rich amounts. Let it then infiltrate the surface for 3 minutes. Carefully air-dry the surface followed by flossing then light cure for 40 seconds. Repeat the process a second time, but with only 1 minute infiltration time.

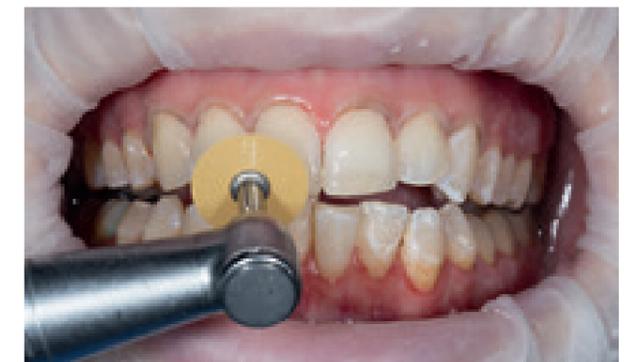
Fig. 7: After the Icon-Infiltration process the enamel surface will present a matte appearance. To get a shiny and smooth surface use 3M polishing discs. Start with a light orange disc on a dry surface and carefully polish away any unevenness. Moreover, rinse the surface with water, air blast and finish the polishing process by using a yellow disc.

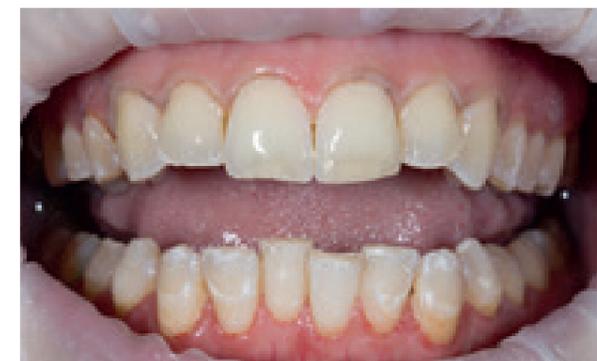
Fig. 8: Final result.

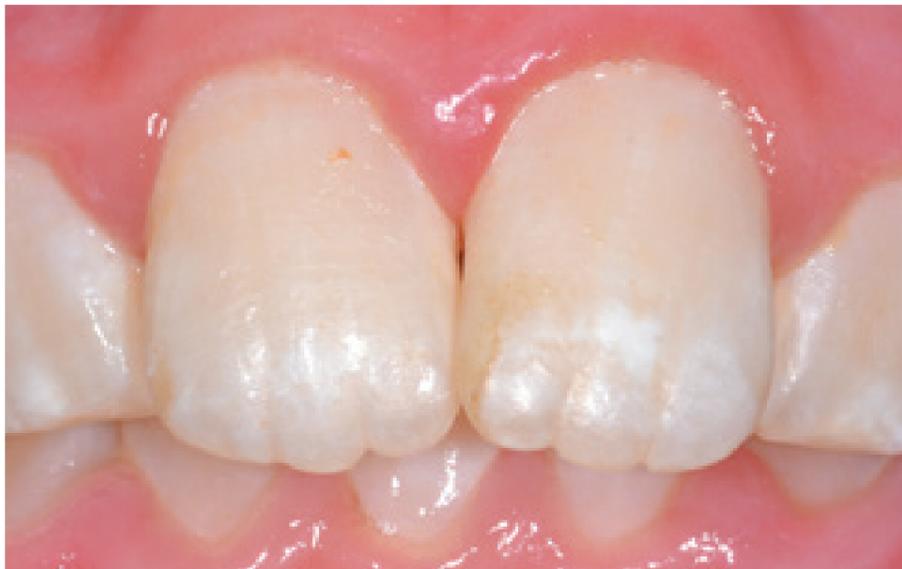
Fig. 1: Initial situation of the fluorotic spots before treatment with Icon. Especially the appearance of the teeth 21 and 11 were esthetically compromising.

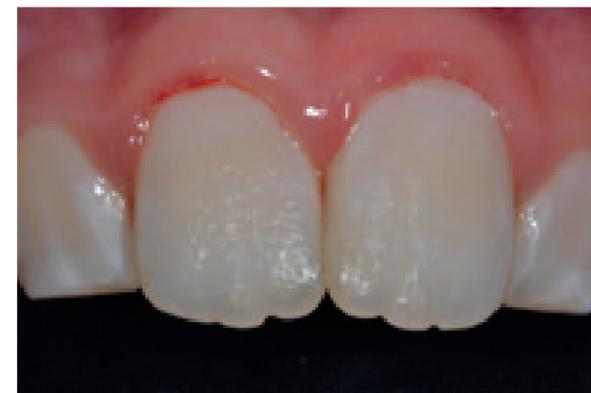
Fig. 2: After polishing the teeth with pumice the resin barrier Opaldam Green (Ultradent®) was applied in order to isolate the working field and to protect the gingiva which both is mandatory when using Icon. Fig. 3: To condition the surface Icon-Etch was applied for 2 minutes. The etching gel was removed with water spray for 30 seconds and the surface was dried. The etching step was repeated 4 times. Especially with fluorosis it is often necessary to repeat the etching step several times to gain sufficient access to the lesion body. Fig. 4: In the next treatment step Icon-Dry was applied for 30 seconds. Immediately after the wetting with Icon-Dry the operator gets a preview of the masking effect. If the lesions do not diminish the etching step should be repeated. After 30 seconds the surfaces were thoroughly dried with oil free and water-free air.

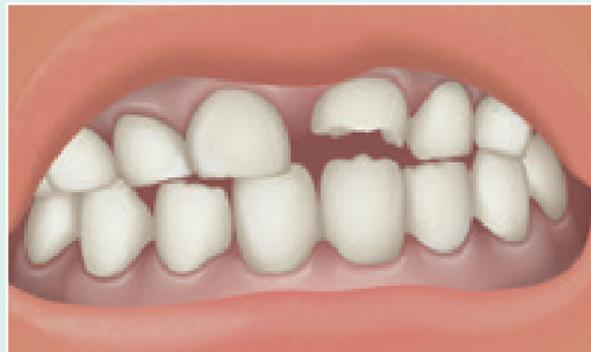
Patient history or etiology. A trauma or apical periodontitis in the primary tooth.

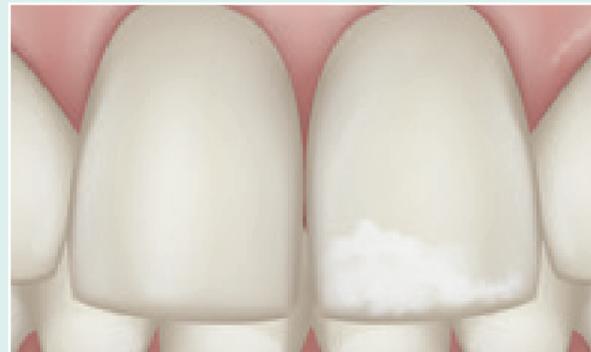
Affected tooth/teeth. Usually one or several teeth. Associated lesions can often be found on opposite jaw.

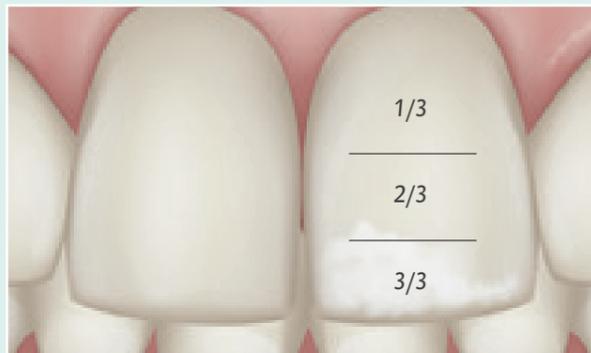
Localization. Mostly affects the facial surface (the side closer to the lips or cheek).

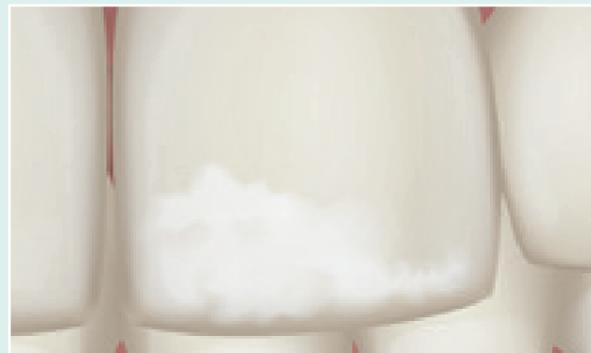
Border. Well-demarcated. It also could be a quantitative defect associated with reduced localized thickness of enamel (enamel hypoplasia).

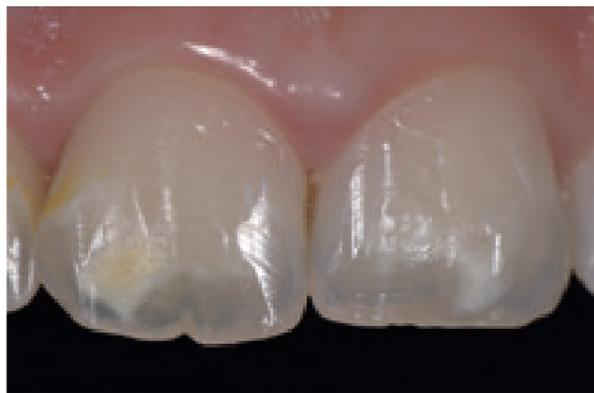
Fig. 1: Initial situation with two lesions due to trauma on teeth 11 and 21 (white lesion on 21 and slightly yellow on 11). The third incisal portion of teeth is concerned with a high translucency of the edge. As the lesion appears relatively deep, we know that we need to infiltrate in depth. So we eliminate a very thin layer of enamel with the bur.

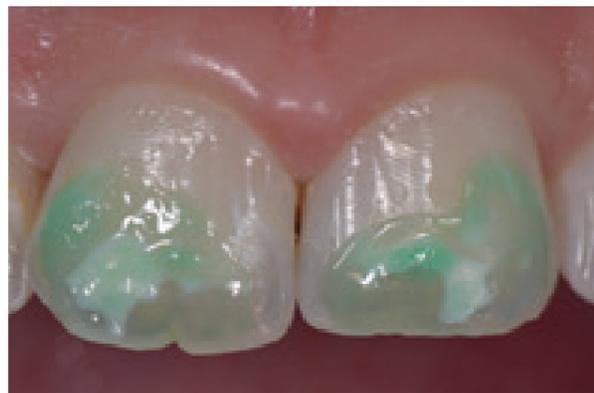
Fig. 2: First application of Icon-Etch.

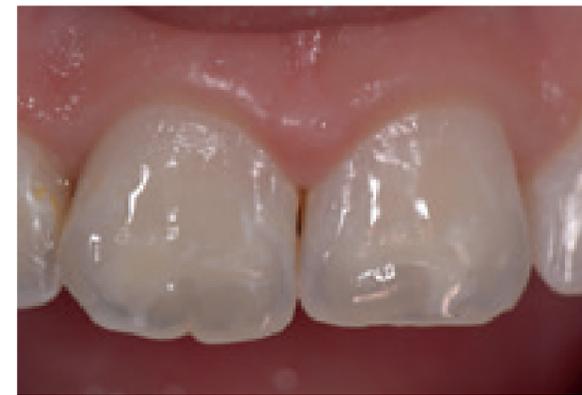
Fig. 3: After rinsing, drying and application of Icon-Dry, we note a slight masking of the lesions. But not enough to infiltrate.

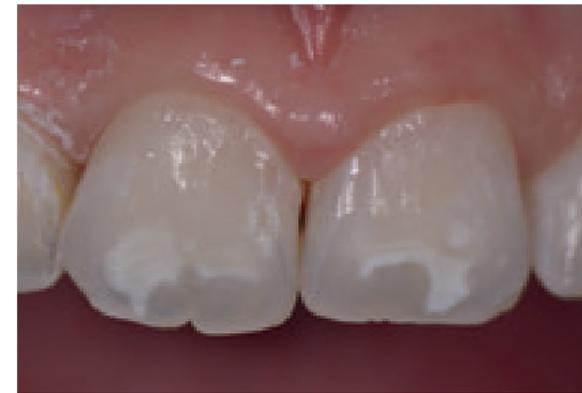
Fig. 5: After rinsing and drying.

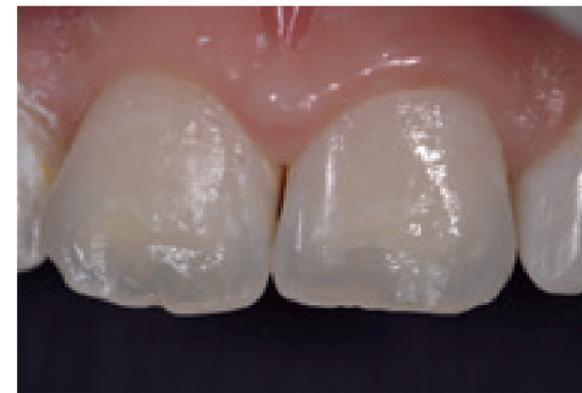
Fig. 7: After infiltration with Icon-Infiltrant and light curing. The masking is efficient.

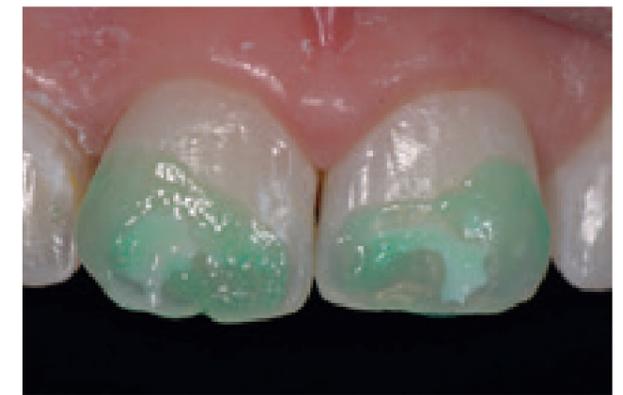
Fig. 4: Second application of Icon-Etch.

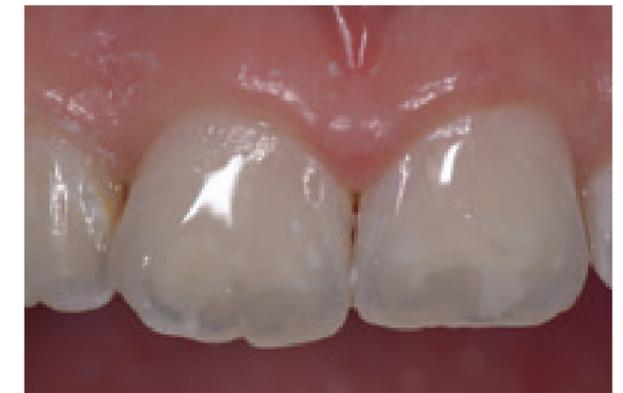
Fig. 6: Icon-Dry allows a partial masking of the lesion. That shows that ethanol can infiltrate the porous lesion. We know that Icon-Infiltrant could infiltrate too.

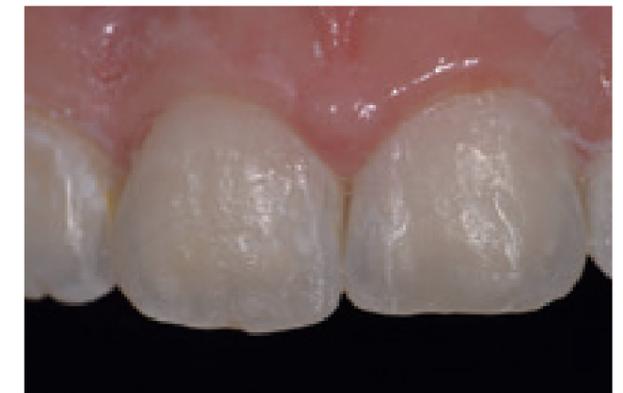
Fig. 8: A small amount of enamel composite is sufficient to compensate the very small loss of substance of enamel due to the combination of bur and acid erosion. The lesions are not visible anymore.

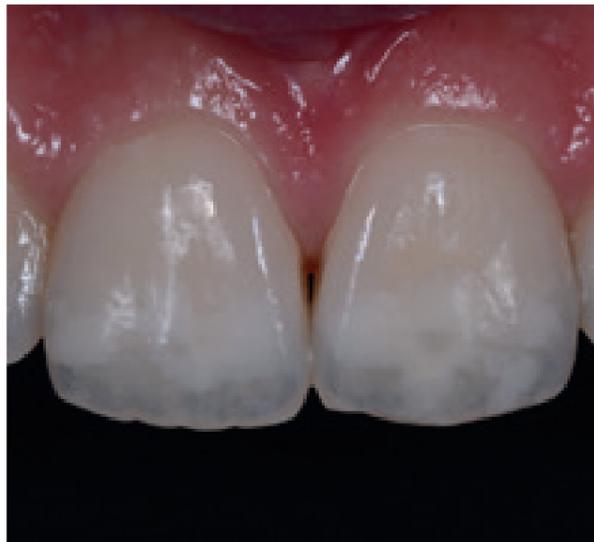
Fig. 1: Initial situation. With a black background the contrast gets better, but the white spots are still not clear. Britt is dissatisfied with the white spots on teeth 12, 11 and 21.

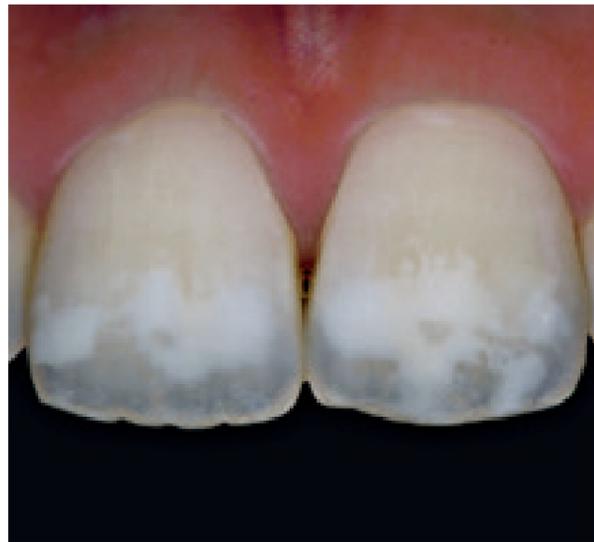
Fig. 2: A cross-polarised photo with high colour intensity of the initial situation. In a sudden the white spots are clearly visible.

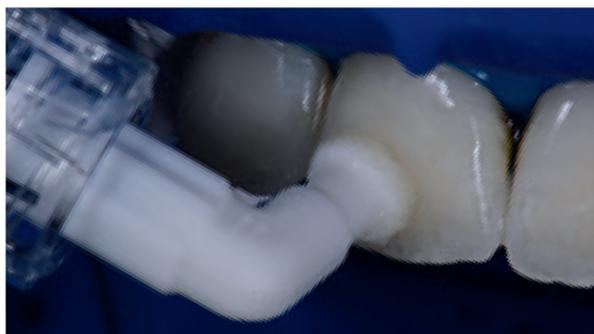
Fig. 7: Applying the methacrylate infiltrant (Icon-Infiltrant, DMG) with the special smooth surface (sponge) tip from DMG. Infiltrating the porosities with the infiltrant (Icon-Infiltrant, DMG). Polymerisation with glycerine gel is performed to remove the surface oxygen inhibition layer.

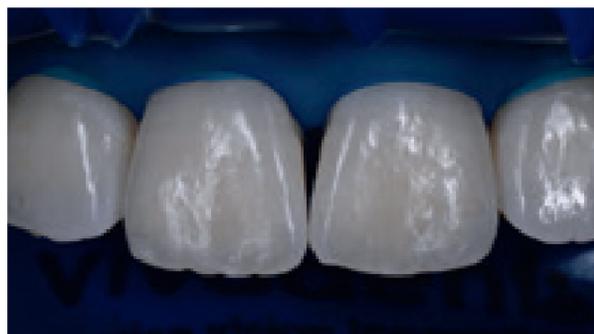
Fig. 8: Situation after polishing with rubbers (Brownie and Greenie, Shofu) and felt disc with aluminium oxide (Flexibuff with Enamelize, Cosmedent).

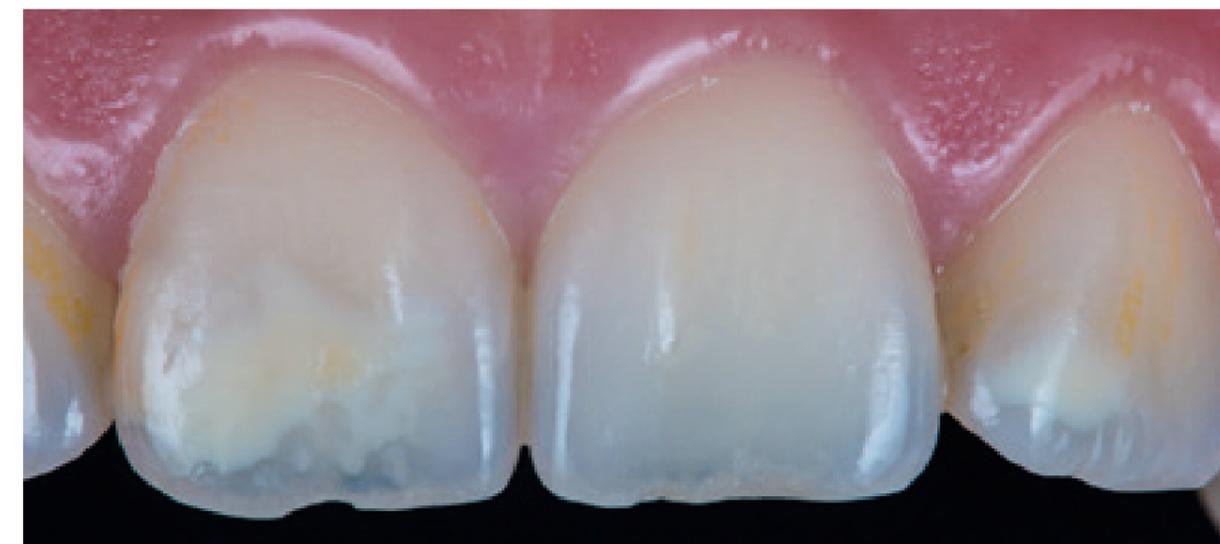
Fig. 1: Initial situation with large white spots on the incisal half of 11 and 22. Patient experienced trauma on primary incisors at the age of 4. The history, shape, location, asymmetry and absence of similar lesions on the other teeth indicate the diagnosis of post traumatic white spots. The opaquer areas of the white spots indicate deeper parts of the lesion that will require a deeper treatment.

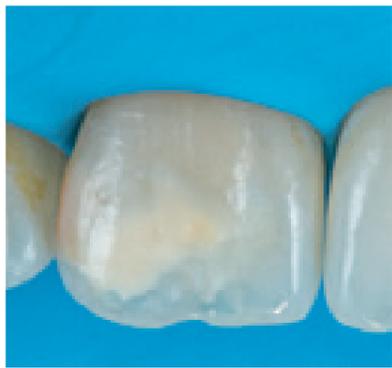
However, for post-traumatic hypomineralization, the edges of the lesion can have acute or obtuse angle [3, 5].

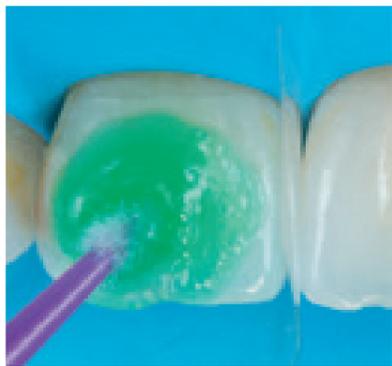
Fig. 3: The depth of the lesions indicates a thicker well-mineralized surface layer that needs more than just acid erosion in order to access the body of the lesion for infiltration. To accelerate the process and reach good final result, a red ring bur is delicately used on the surface layer prior to the acid. Fig. 4: Prior to each etching step, the surface layer is sandblasted as well as the healthy enamel surrounding the white spots to optimize the result and limit the »edge effect« due to an insufficient infiltration of the margin of the lesion.

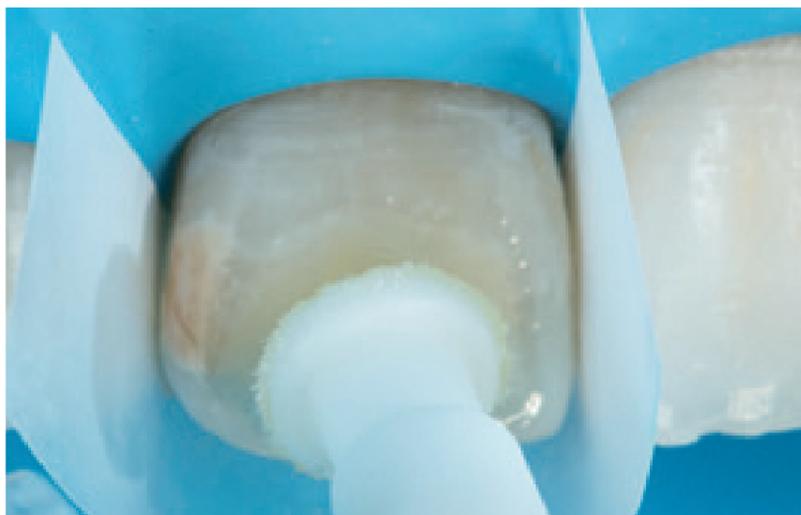
Fig. 6 and 7: After several steps alternating mechanical and chemical erosion, the use of Icon-Dry finally shows a satisfied result with a dramatical masking of the white lesions.
