Icon smooth surface

Case Reports

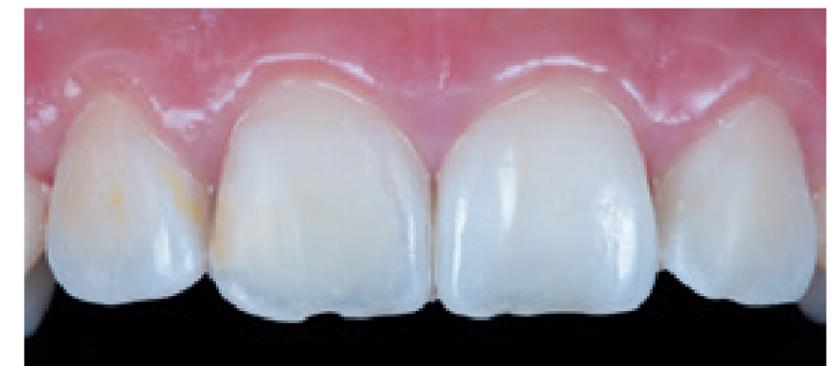
Fig. 11: Final situation one year after the treatment show an amazing stability of the infiltration result.

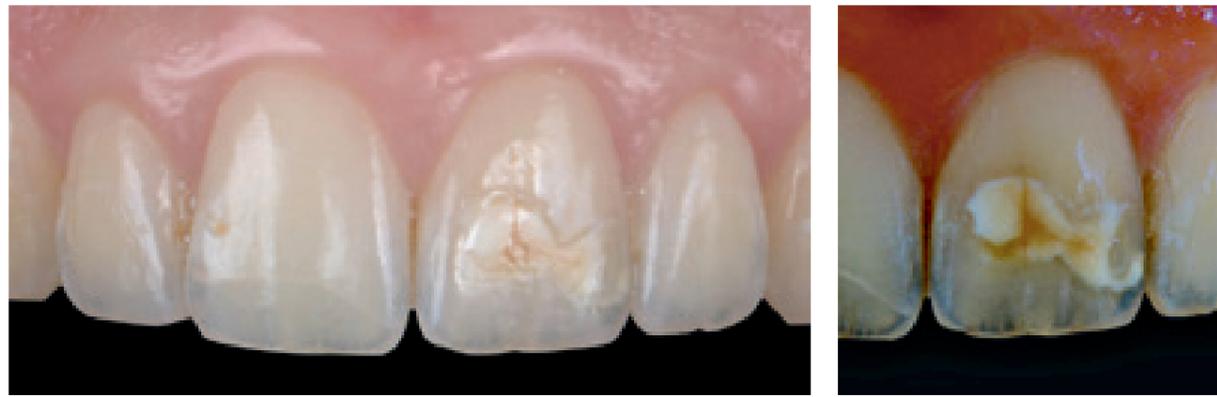
Fig. 1-2: Initial intra oral picture and initial polarized picture.

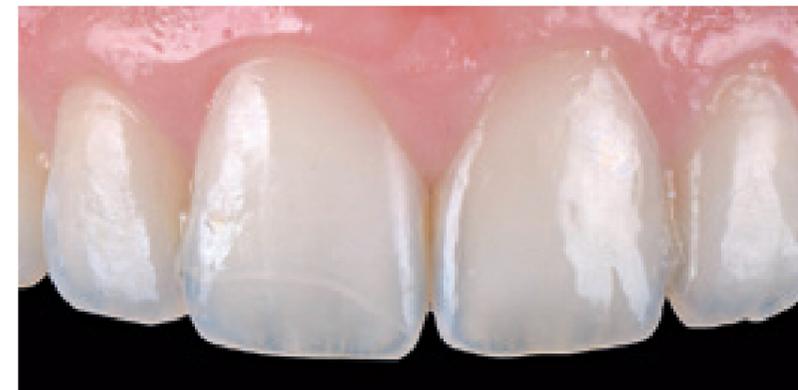
Fig. 9: Final intra oral picture. After two months the result is satisfactory. The beauty of this internal dentin stratification has been conserved!

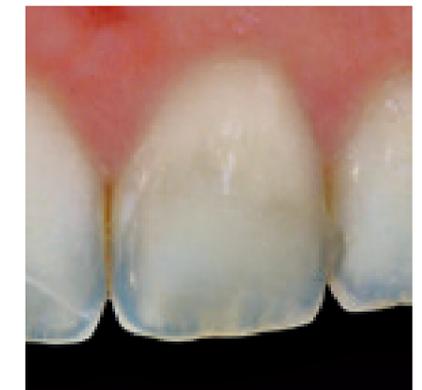
Fig. 10: Final polarized picture

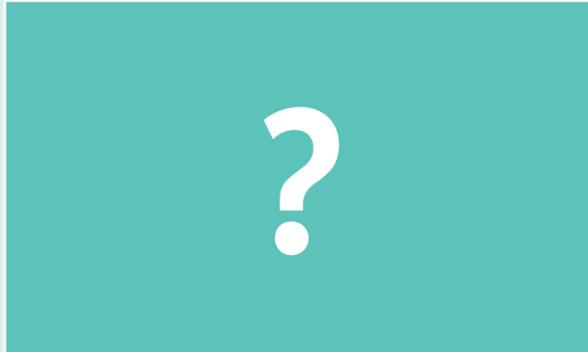
Patient history or etiology. Unknown, non specific.

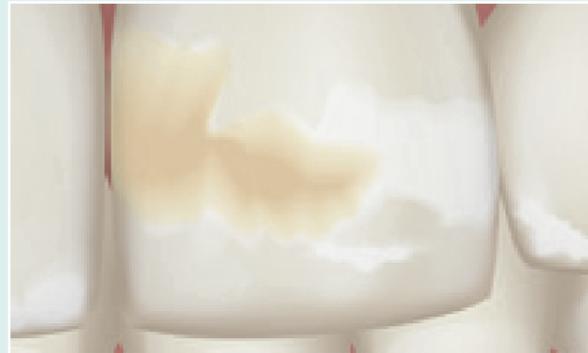
Border. Well-demarcated, a qualitative defect affecting enamel translucency. No changes to the enamel thickness.

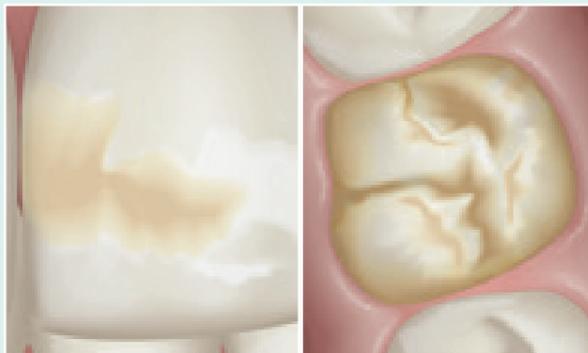
Color. Whitish-cream or yellow-brown. The intact enamel surface is hard, smooth and often hypermineralised following posteruptive maturation, the subsurface enamel is soft and porous [3,4].

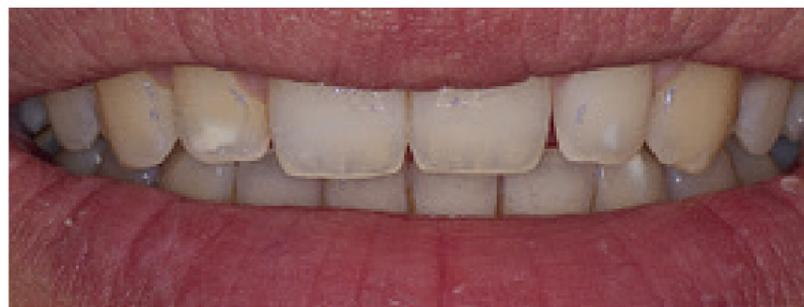
↑ Fig. 1: Initial view of a lesion on the upper right lateral incisor.

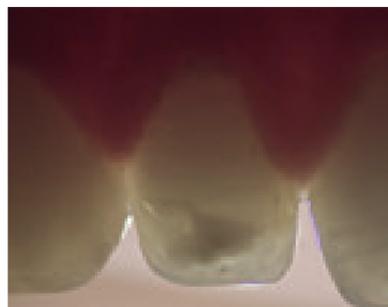
This classification regroups three major types of enamel opacities: Superficial, mixed and deep lesions. Each category has specific clinical features in relation with the topography of the lesion and the proper treatment approach will be then adopted accordingly. While keeping in mind that superficial lesions represent the easiest category to achieve a favorable treatment outcome, the idea behind the treatment concept proposed implies the transformation of mixed and deep lesions into superficial ones using abrasive procedures before proceeding with their infiltration [2]. This clinical case report describes a suggested treatment of a deep lesion affecting a lateral maxillary incisor related to MIH based on transillumination, focalization and lesion transformation to achieve a good aesthetic result.

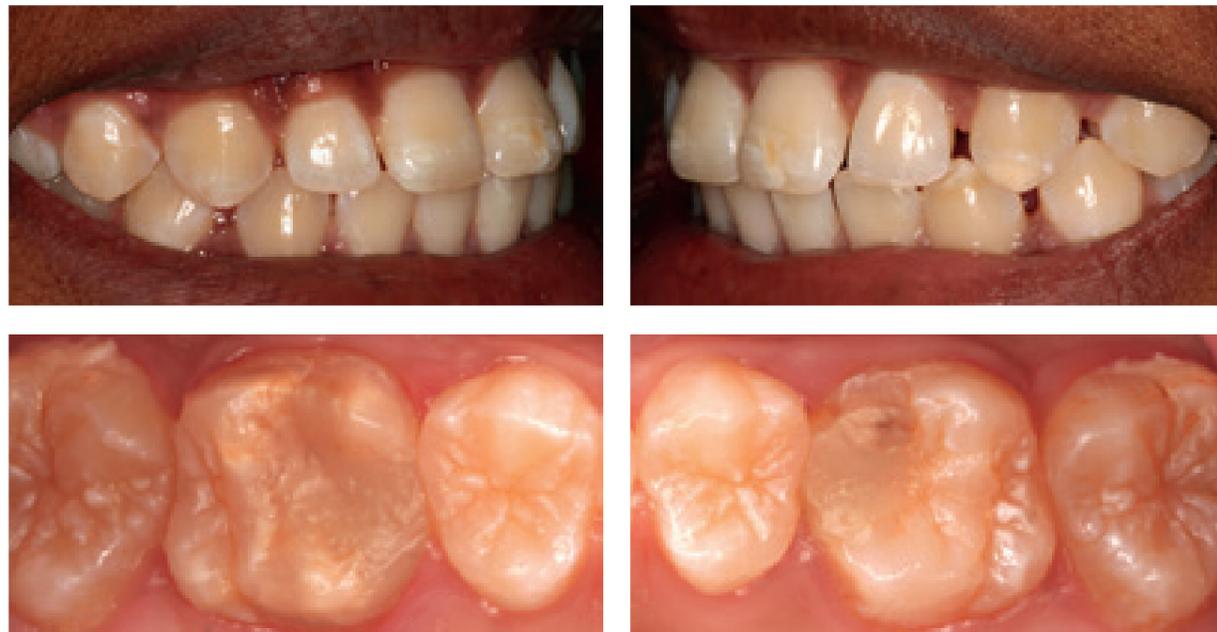
Fig. 1: Patient with main lesions in upper incisors, left canine and first upper molars, characterizing MIH. The lesions on mesial surface of molars were already restored with composite

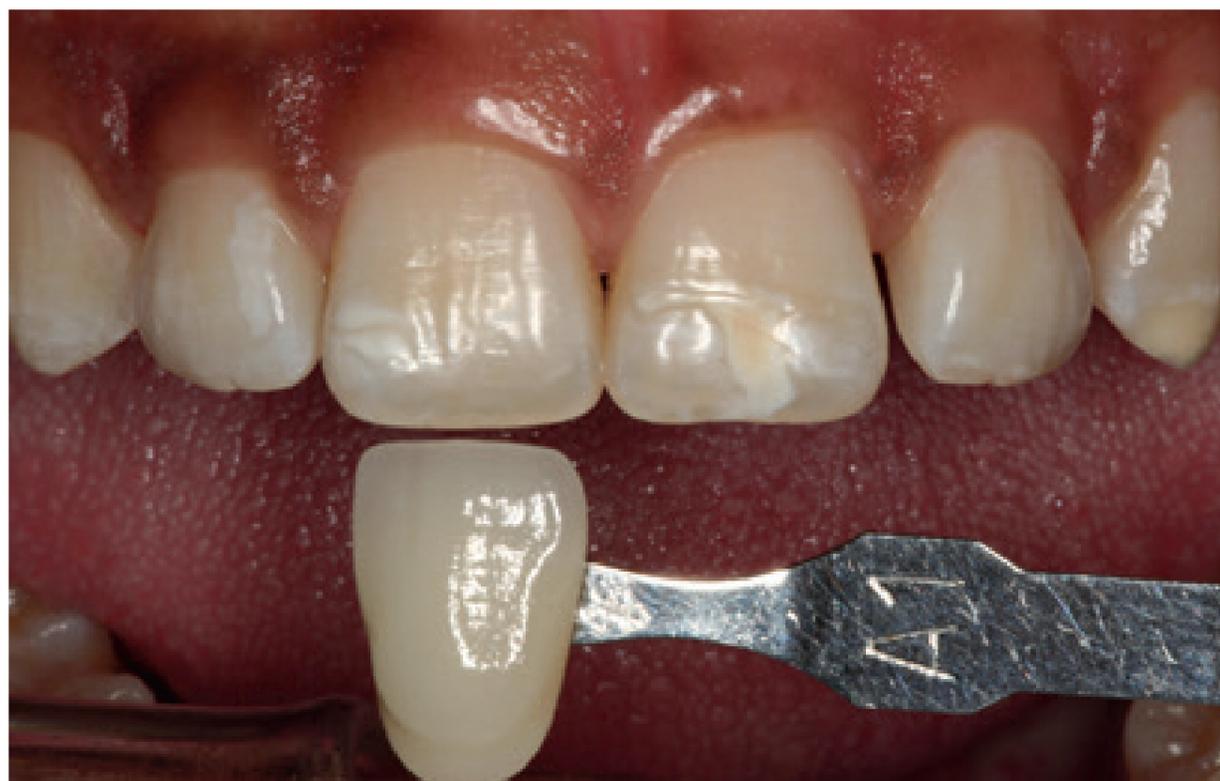
Fig. 3: As a composite would be necessary to cover the deep infiltrated area, the shade selection was performed as the first step.

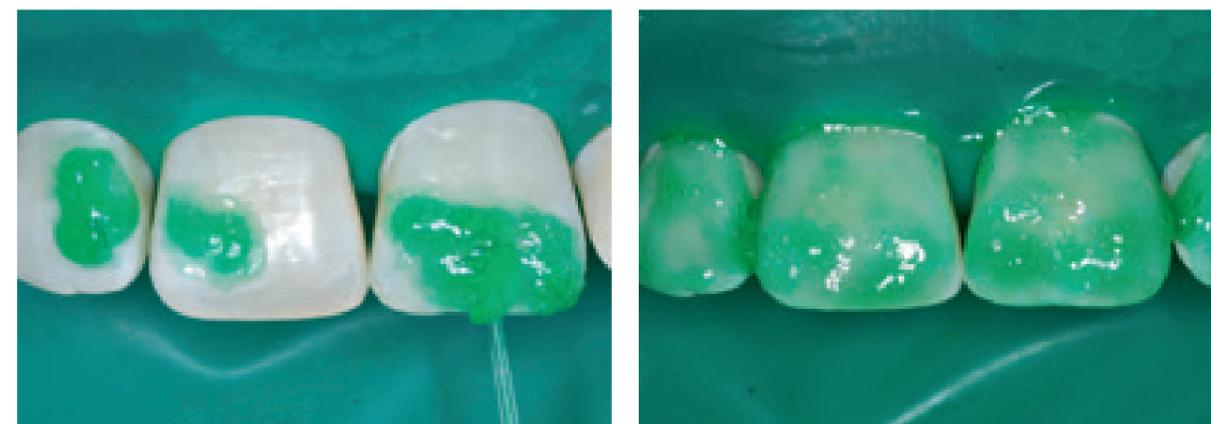
Fig. 5 A-B: After that, etching with hydrochloric acid gel was performed only over the main lesions, in order to remove the external surface of the shallow ones, and increase the permeability of the bur opened deep ones. The acid (Icon-Etch, DMG) was applied for 6 minutes over the main lesions, since shorter times are usually insufficient on those cases. Then, the whole surface was additionally etched for 2 minutes, in order to etch the small lesions spread over the teeth surfaces.

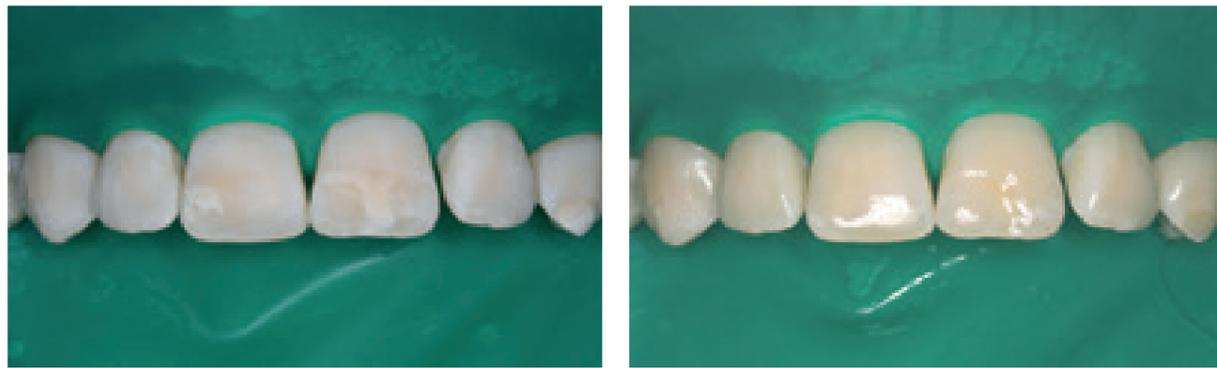
Fig. 7 A-B: After that, the surface was dried with air and the resinous infiltrant (Icon-Infiltrant, DMG) was applied over the labial surface of all teeth, remaining undisturbed for 3 min. The excess was removed with an air stream and the light-curing was performed during 40 s on each teeth. Then the infiltrant was applied again and let over the surface for 1 minute. The excess was removed and the light-curing was performed.

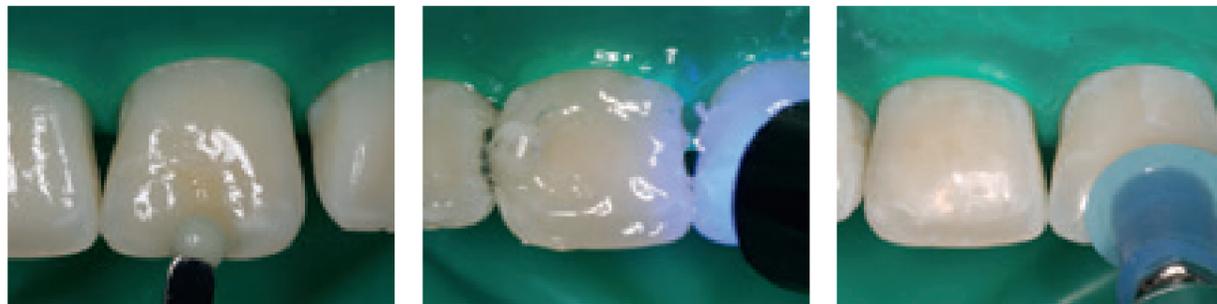
Fig. 9 A-C: Next, the deep infiltrated lesions were restored with composite (Fig. 9 A). A layer of glycerin gel was applied over the whole infiltrated teeth surface in order to eliminate the environmental oxygen, which can inhibit cure of the external infiltrated layer, providing a better conversion degree of the monomers in polymers (Fig. 9 B). After that, the surface was first polished with abrasive disks and then with felt disks and polishing paste.

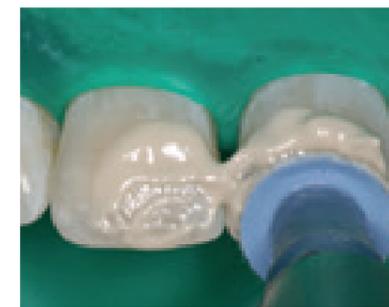
Fig. 9 A-D: Next, the deep infiltrated lesions were restored with composite (Fig. 9 A). A layer of glycerin gel was applied over the whole infiltrated teeth surface in order to eliminate the environmental oxygen, which can inhibit cure of the external infiltrated layer, providing a better conversion degree of the monomers in polymers (Fig. 9 B). After that, the surface was first polished with abrasive disks and then with felt disks and polishing paste.

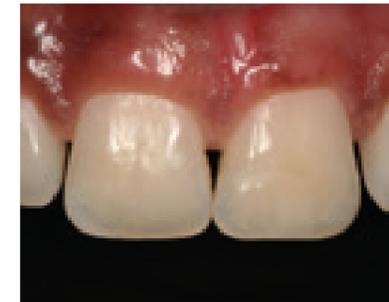
Fig. 10 A-B: Post-treatment results.

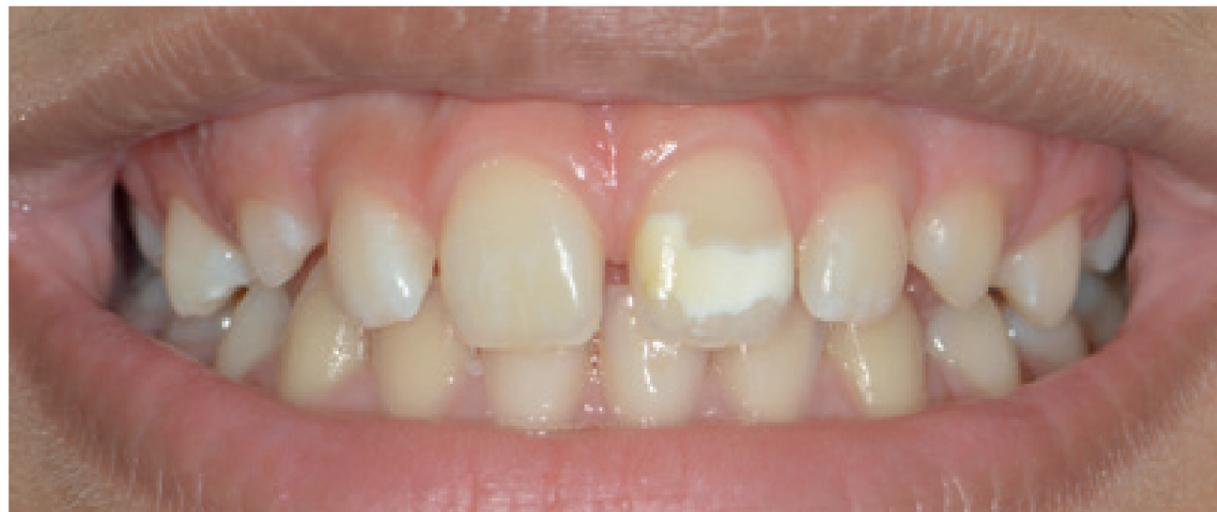
Fig. 1: Initial aspect of the lesion.

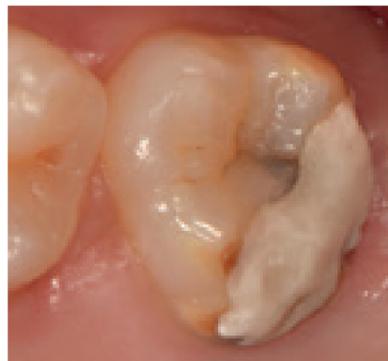
Fig. 2: Hypomineralization in the maxillary molar associated with MIH.

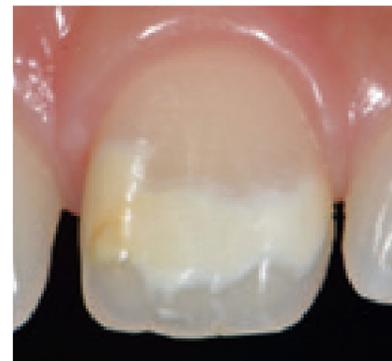
Fig. 3: Closer view of the white-yellow lesion in the enamel.

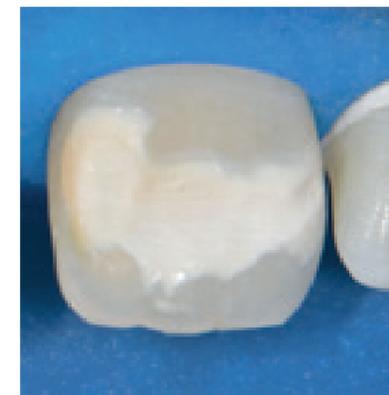
Fig. 5: After partial removal of affected enamel, (note that the discolored inner enamel remains), resin infiltration technique was performed using Icon-Infiltrant for smooth surfaces kit (DMG, Hamburg, Germany). The rubber dam isolation was applied.

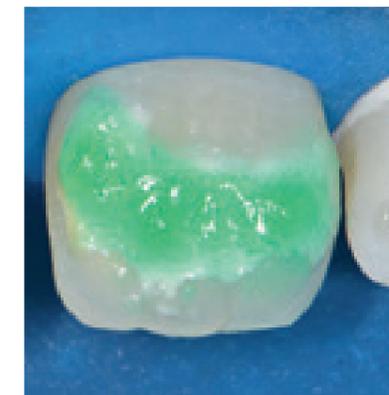
Fig. 6: The surface was eroded with 15 % HCl gel (Icon-Etch) for 2 minutes. After that, the acid was fully washed with air/water spray and dried.

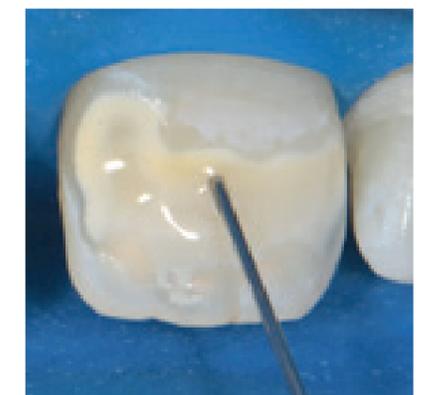
Fig. 7: In order to completely remove water from microporosities, the lesion surface received the application of 99 % ethanol (Icon-Dry) for 30 s, and again air-dried. After Icon-Dry application, when the lesion becomes invisible or is reduced in intensity, that means the etched lesion is ready to be proper infiltrated. When no change happens, the preparation can be extended in depth, and/or a new etching step is performed, until some masking with Icon-Dry is observed. The total depth of enamel removal in this clinical case was about 0.5 mm, and the acid was applied for 6 minutes (3 applications of 2 minutes). This progressive preparation is made to allow the minimal invasive intervention as possible.

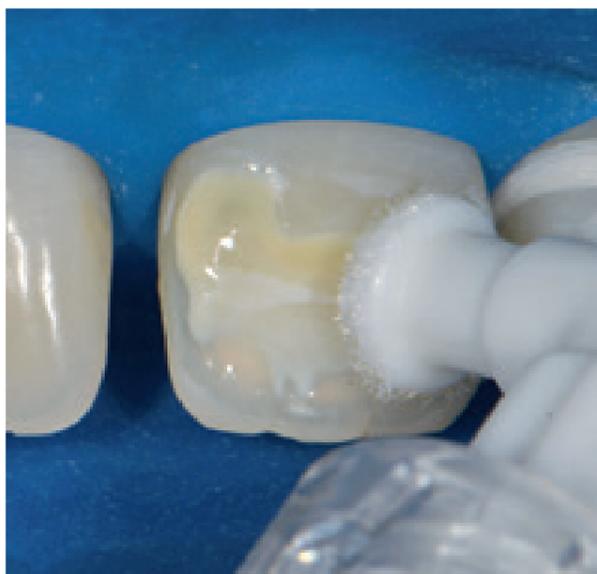
Fig. 8: Finally, the Icon-Infiltrant was applied in two steps. The first application was performed for 5 minutes, with surface protected from ambient light with an opaque screen.

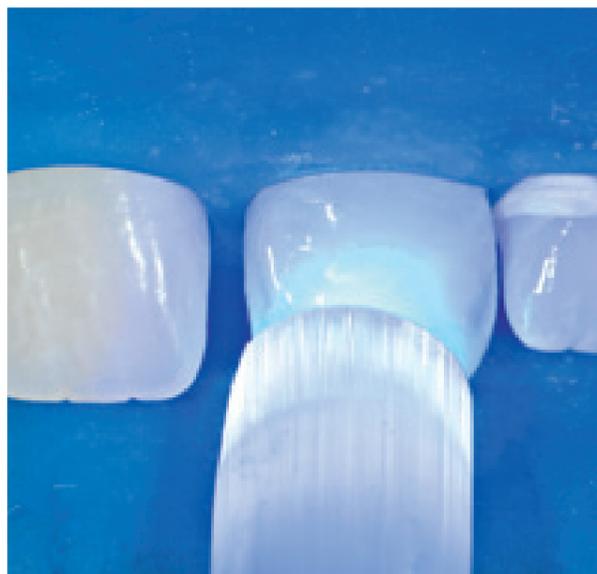
Fig. 9: Then excess was removed from the surface with a blow of air, and light curing was performed for 40 s. The infiltrant was applied a second time, for 1 minute, and again light cured for 40 s.

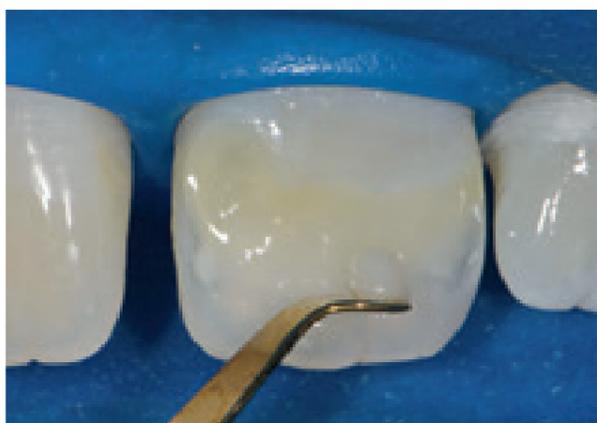
Fig. 10: Then, composite resin was applied (Filtek XTE Supreme, 3M ESPE, St Paul, MN, USA) in increments. No separated bonding agent was applied, since the Icon-Infiltrant per se is able to promoted adhesion to the tooth structure [23]. Each increment was light cured for 40 s. Finishing and polishing procedures were performed (Soflex discs, 3M ESPE).

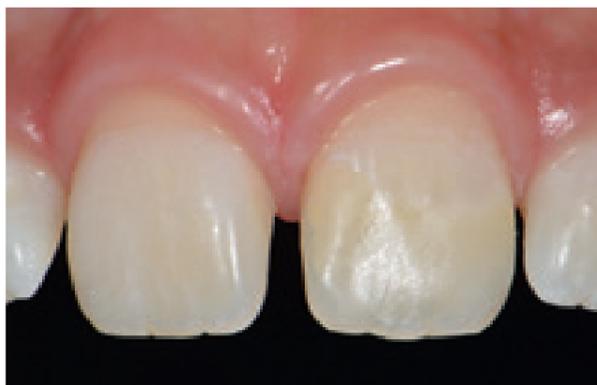
Fig. 11: Immediate outcome of the teeth in closer look.

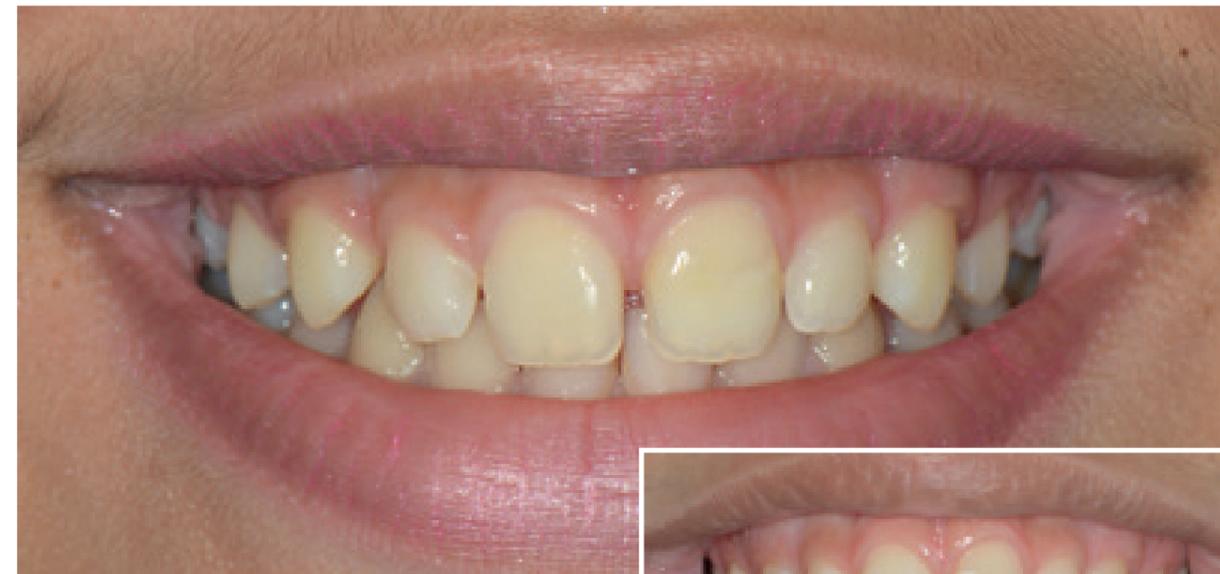
Fig. 12: Final outcome after one month.
